**Midland Road, Masbrough, Rotherham**

**Road Safety Audit Stage 1**

November 2023

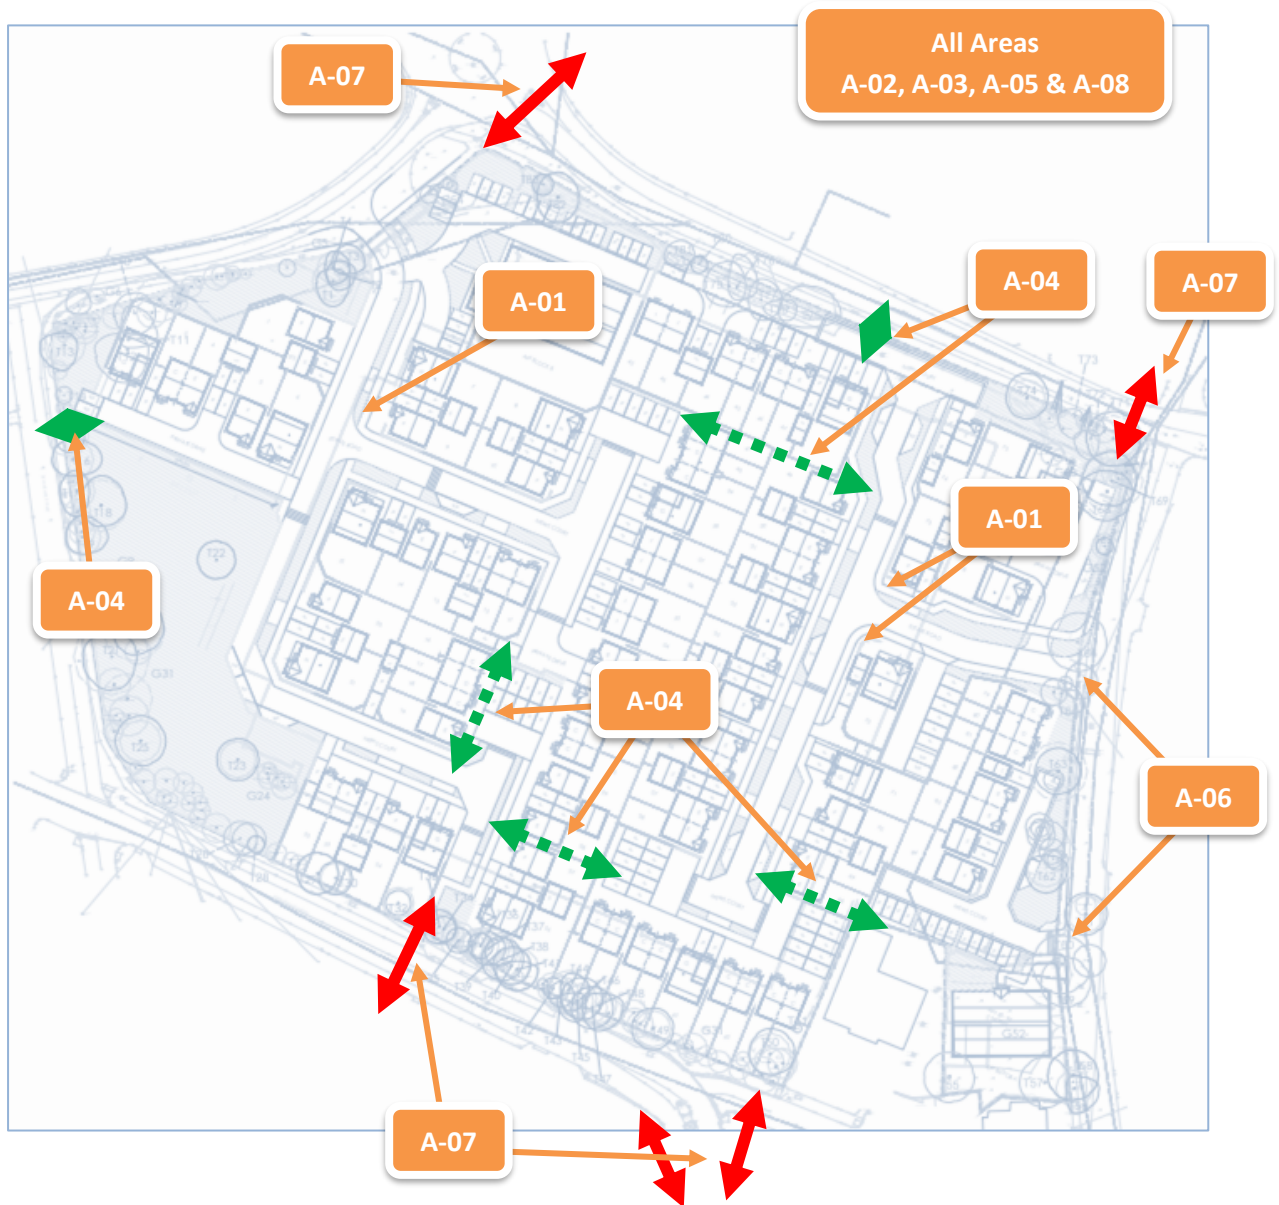
# Problem Location Plan

Each of the auditors' responses is classified as a 'Problem' that is likely to result in a significant road safety hazard. All comments and recommendations are referenced to the detailed design drawings and the locations have been indicated on the plan at the end of the report.
